Mining Modification of River Systems: A case study from the Australian Gold Rush

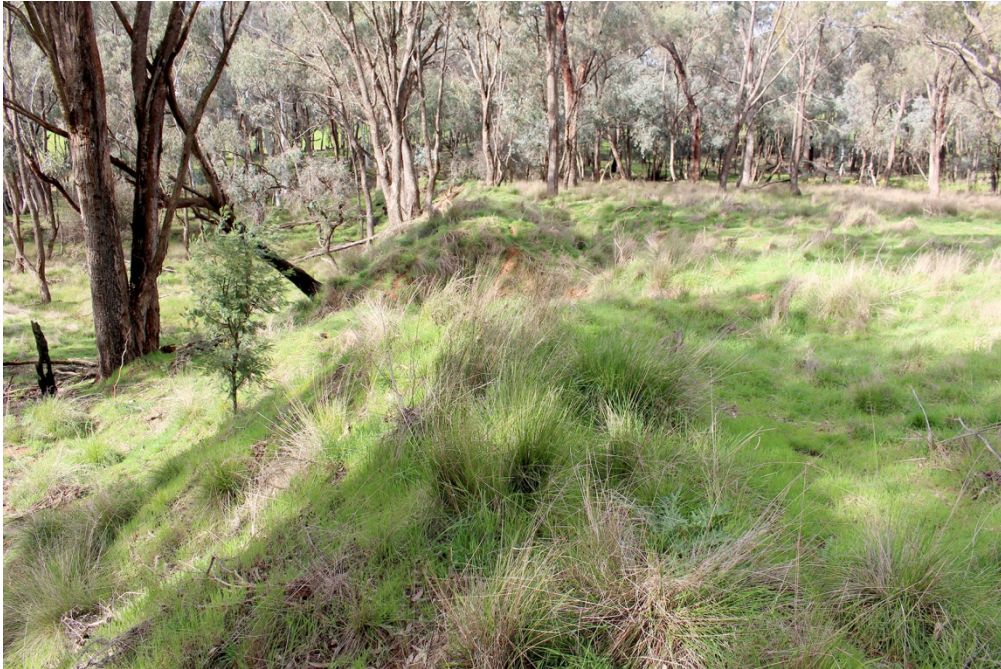
Figure 10: Sludge dam of Pund & Co in Three Mile Creek with embankment centre-left and flat surface on the right

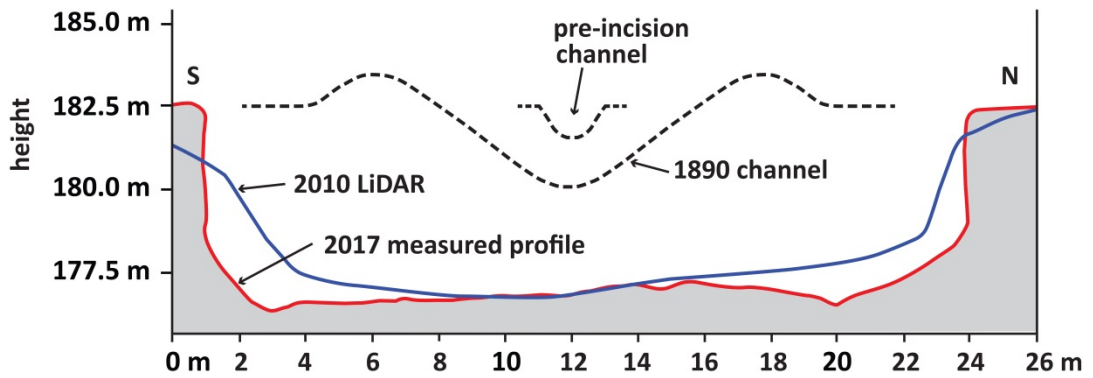
Figure 12: Hodgson Creek cross-section comparison, located between Diffey Lane and Rusholme Road at Tarrawingee

Channelizing and straightening of Hodgson Creek occurred during the 1880s, removing the stream meanders and creating a straight channel with a steeper gradient (Figure 12). The Victorian government began spending large sums on drains to alleviate the sludge problem at various mining centres from the late 1850s but the Ovens goldfield was overlooked for many years, despite decades of complaints and protests from local farmers (Lawrence & Davies, 2014). Construction of the Tarrawingee sludge channel finally began in April 1879, with most of the work done over the following decade with shovels and wheelbarrows (Kay, 1954; *OMA*, 19 April 1879:8a). The two local government authorities responsible, however, each built their section of the channel to different engineering specifications. The North Ovens (downstream) section was, to begin with, 0.9 m wide at the base, with sloping banks and embankments on each side giving a depth of 3.2 m and a maximum width of 10 m (*The Age*, 19 April 1879:5g). This section of the channel had a fall of 3.8 m per kilometre (Sludge Board 1887:147). The Beechworth (upstream) portion, however, was designed to carry a much larger volume of mining waste and flood water (*OMA*, 10 April 1884:2b, 10 December 1885:1d).
