Mining modification of river systems: A case study from the Australian gold rush

Mining Modification of River Systems: A case study from the Australian Gold Rush

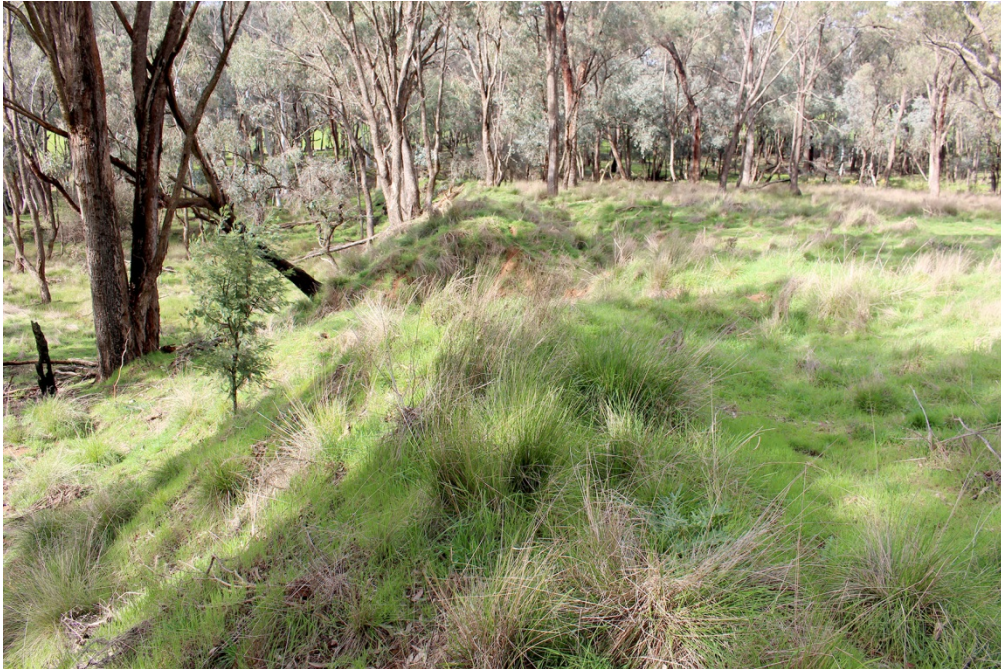
Figure 10: Sludge dam of Pund & Co in Three Mile Creek with embankment centre-left and flat surface on the right

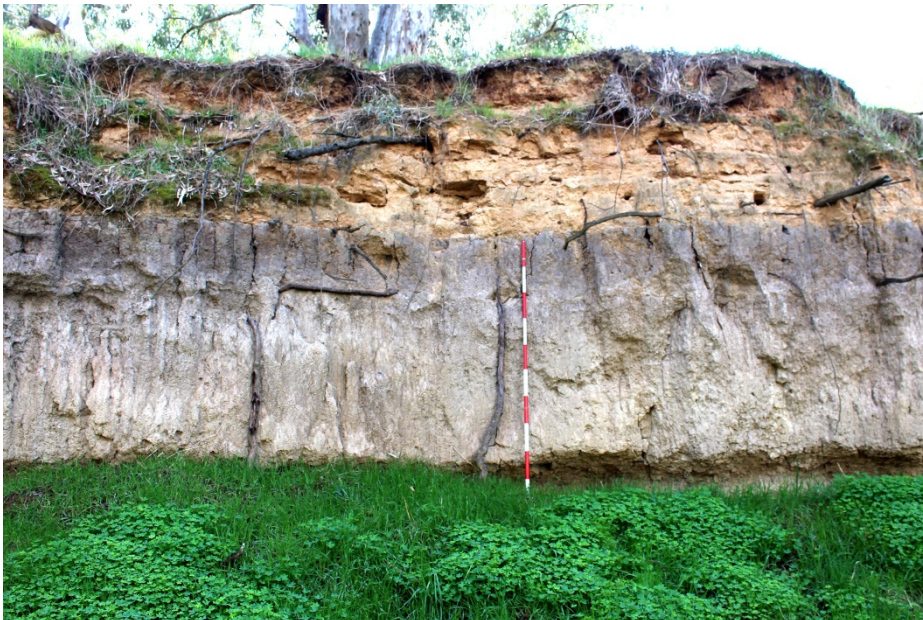
Figure 11: Vertical exposure of current sludge channel in Hodgson Creek at Tarrawingee showing yellow mining sludge above grey pre-European alluvium. Scale in 20 cm increments

Three Mile Creek flows from its confined valley and emerges as Hodgson Creek on the floodplain of the Ovens River. Where the bank of the creek has been exposed through erosion there is a clearly visible band of pale yellow (10YR 5/6) sediment at the top of the soil profile. This distinctive band is generally 1-2 m thick and has been identified along the banks of the creek for most of its length across the floodplain (Figure 11). The yellow band sits above a dark grey (10YR 4/1) organic floodplain deposit. Macroscopic examination of the mining sediment band reveals that it is comprised of multiple thin laminations of fine-grained silt interspersed with occasional sandy lenses. This sediment has substantially changed the soil structure of the floodplain. The previous structured profile rich in organic matter has been buried by a uniform deposit that is largely devoid of organic material. Similar mining-related deposits have been described in rivers in New Zealand (Clement et al., 2017), the UK (Howard & Macklin, 1999; Macklin et al., 2014) and California (James, 1999).

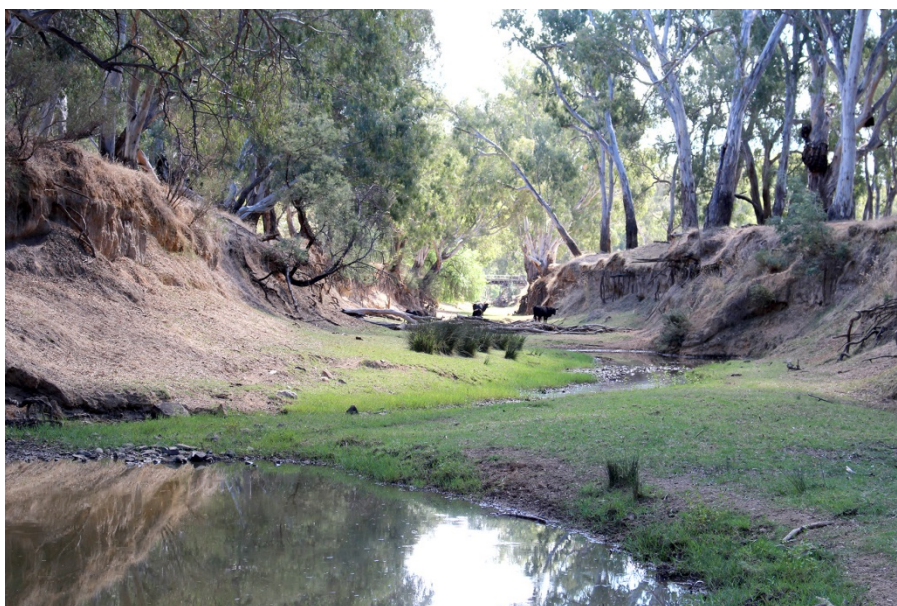
Figure 14: Looking west down the Tarrawingee Sludge channel on Hodgson Creek showing active modern erosion. The cow in the distance provides a scale.

Councilor Gunn, whose land fronted the channel, suggested that the cause of deposition in the Ovens was the construction of settling dams that sent down clear water which had begun to cut into accumulated silt in the channel and move it into the Ovens river. Eight hectares of Gunn's land fronting the sludge channel was swept away by erosion after heavy rains, and the bed of the creek was now 1.2 m lower (*OMA*, 12 June 1918:4). Alluvial mining ceased in the upper reaches of Three Mile-Hodgson Creek by the 1940s. Incision at Tarrawingee, however, was still active in the decades that followed, with continued widening and deepening of the channel by erosion threatening road bridges and other infrastructure. Landowners used the creek flats as pasture, with cattle generally having unimpeded access to the creek for water, which exacerbated bank erosion. Grade control measures, in the form of low weirs of rock and concrete, were installed in the creek during the 1990s. These helped to halt further major channel incision and downstream sediment transport, but channel widening has continued in response to unrestricted stock access and storm event-related bank erosion (Alluvium 2014, Figure 14).
