Strategies and climate hopes for collection care and environments at the National Museum of the Philippines

STRATEGIES AND CLIMATE HOPES FOR COLLECTION CARE AND ENVIRONMENTS AT THE NATIONAL MUSEUM OF THE PHILIPPINES

Mariah Camille Calanno¹ and Nicole Tse²

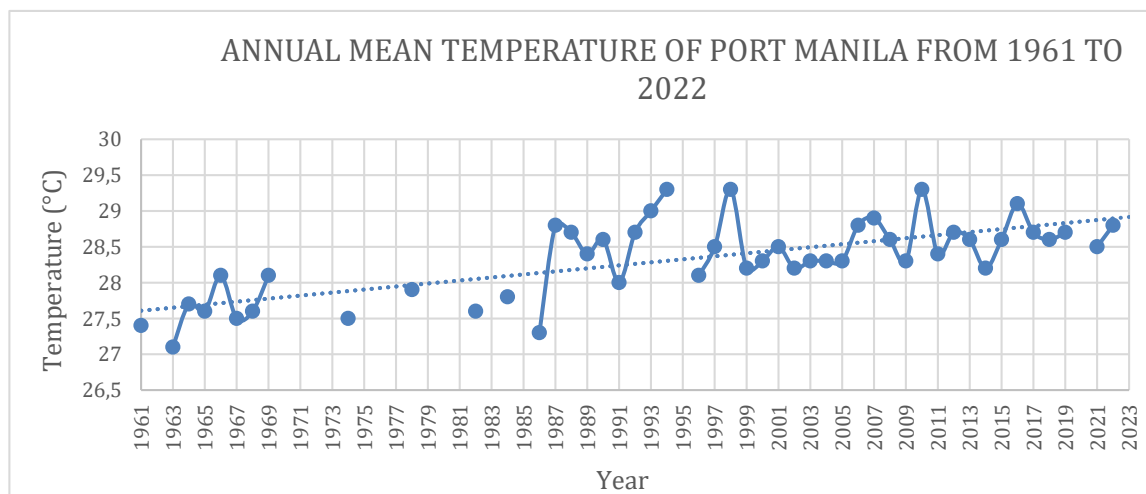
Figure 1. A graph of the annual mean temperatures at Port Manila collected from 1961 to 2022. Data Source: Climate and Agrometeorological Data Section (CADS), Philippine Atmospheric, Geophysical and Astronomical Services Administration (PAGASA).

Like most countries globally, there is a general rise in temperature, and in Manila at least a 1°C has been recorded in the past 30 years as illustrated by the trend line in the historic annual mean temperatures from 1961 to 2021 (Figure 1) (Climate Monitoring and Prediction Section 2023). The Philippine Atmospheric, Geophysical and Astronomical Services Administration (Climate Monitoring and Prediction Section 2023) reports that temperatures average at 28.3°C in the warmest month of May, and highest average 85%RH in September. The Asian Development Bank reports that the Philippines is highly susceptible to climate tropical cyclones, floods, and heat waves, and they are becoming more frequent (Tse, Labrador, Scott & Balarbar 2018).

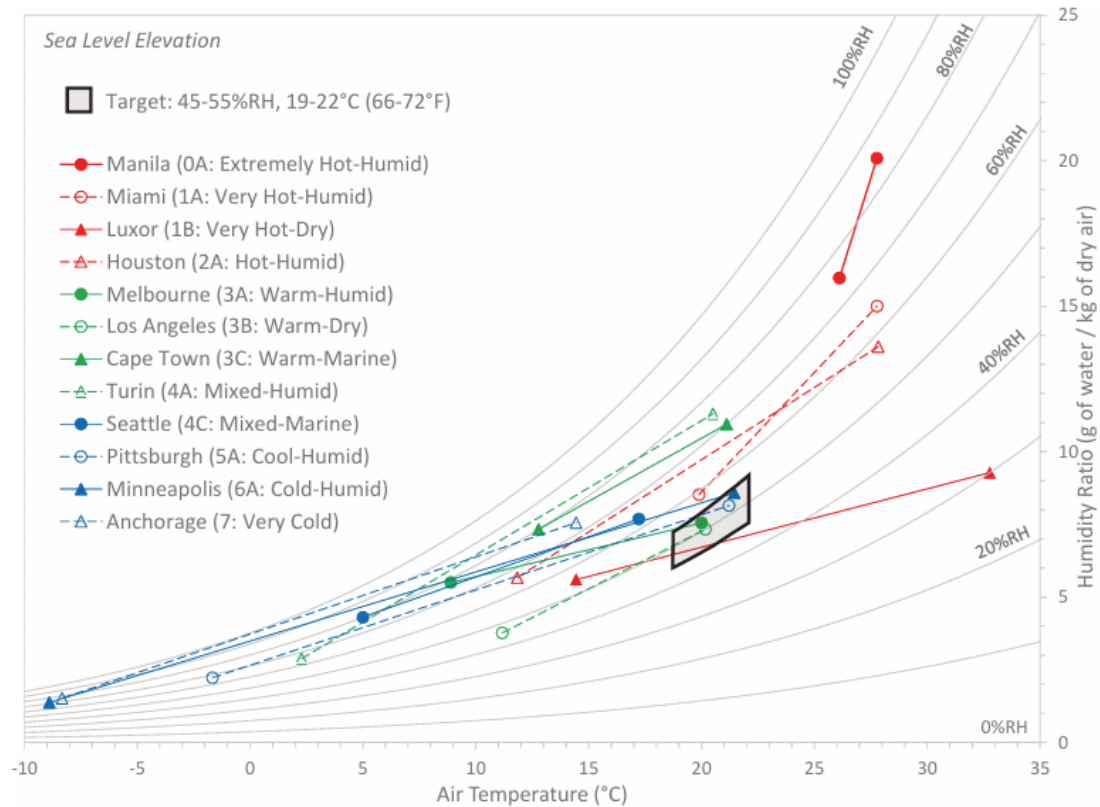
Figure 2. From Figure 6.1 in Taylor (2023), *Managing collection environments: technical notes and guidance, illustrating Manila's climate compared to 11 other countries worldwide* (© 2023 J. Paul Getty Trust)

with different climates like in tropics. Figure 2 from Taylor (2023) for example, shows how Manila's climate compares to eleven other countries worldwide, and collection climates and behaviour is unlikely to be the same. To add, there are just a few publications on the management of environmental conditions and collections in Philippine museums, examples include

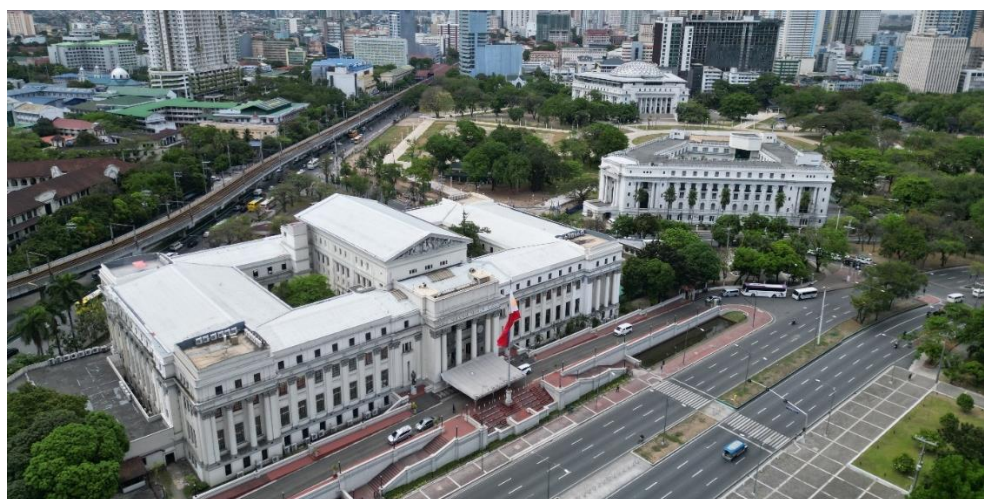
Figure 3. Main: The National Museum of the Philippines Complex in Rizal Park, Manila –The National Museum of Fine Arts (left front), the National Museum of Anthropology (middle), and the National Museum of Natural History (far back). Photographed using a drone by Jubal Kenneth V. Bernal, 2024.

ments. Furthermore, there are some incomplete datasets from the environmental sensors due to technological problems and staff restrictions during the pandemic. Figure 3 illustrates the two NMP buildings, and Figure 4 the floor plans of the galleries and locations of the dataloggers as presented in Table 1. To

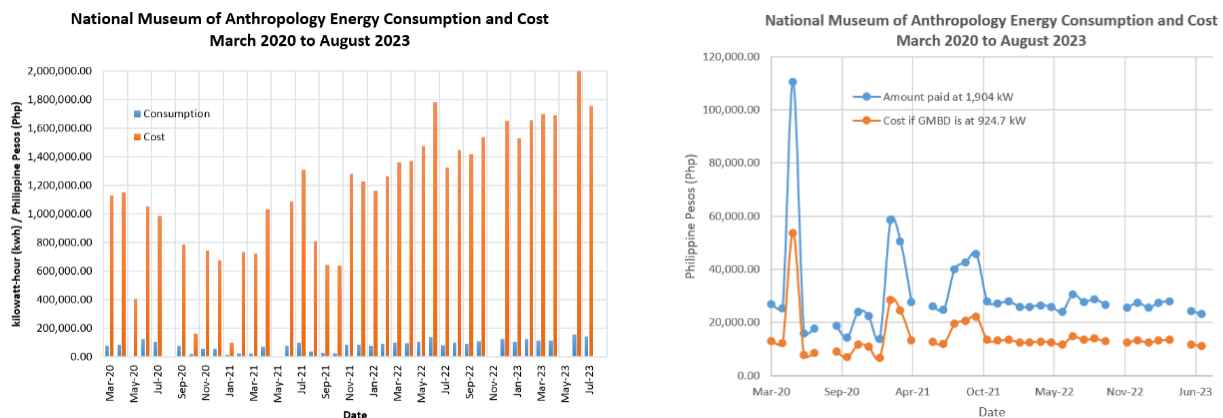
Figure 6. Left: Energy consumption and cost for the NMP from March 2020 to August 2023 in Php, Right: Compares the actual amount paid with GMBD at 1,904kW (blue line) vs the cost if the GMBD is set to 924.7kW (orange line).

Upon reviewing the bill, NMA's Guaranteed Minimum Billing Demand (GMBD) is set at 1,904.00 kW. This is the maximum load set forth by the utility company to its client in kilowatts (kW), and the demand charge used by a building is equivalent to the power rate per kilowatt-hour (kWh) multiplied by the constant GMBD (Manila Electric Railroad and Light Company 2023). In other words, GMBD is used as a multiplier to come up with demand and distribution charges, regardless of power consumption. Accounting for the load consumed, the maximum actual load for 37 months is only 924.70 kW which is almost half of the set GMBD as shown in Figure 6 on the left. It may then be possible to adjust the GMBD setting to 924.70 kW as shown in orange from 1,904.00 kW, and likewise prompt energy reductions for the NMP. Should further energy efficiencies to NMP buildings be incorporated, improvements to the power factor could also bring down costs. As such, evaluation of climate related risk points in the building not only benefit the collection, but acting on the risks and initiating facility upgrades and maintenance, can bring down costs through the incentives offered. This monetary savings can mean a realignment of the budget to economic sustainability and other important operating costs of the museum.

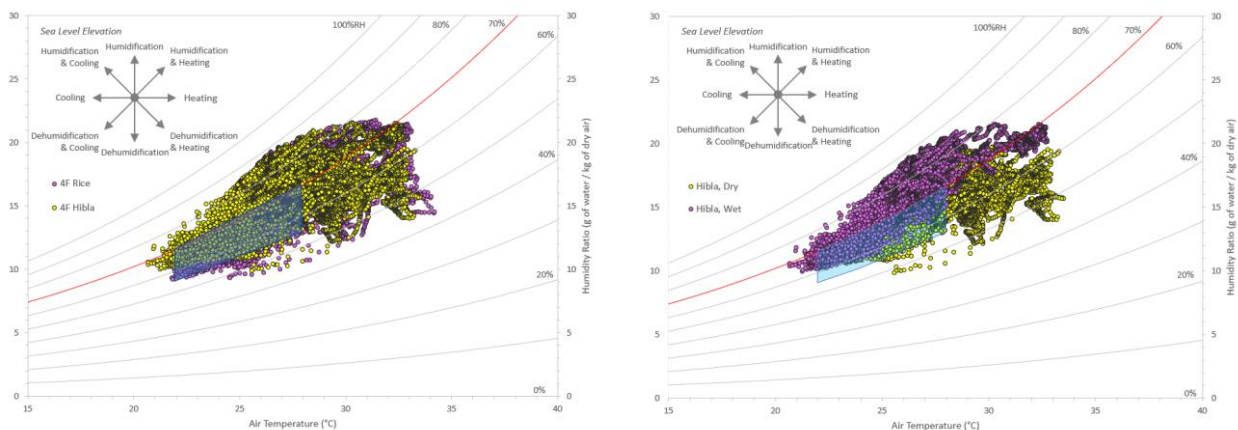
Figure 7. Psychrometric plot of the 4th floor of the National Museum of Anthropology (NMA) Building from March 2020 to March 2021, air conditioning on in the day and off at night. The red line is the 70%RH threshold for biodeterioration. Left: 4th floor Rice Gallery facing Southwest compared to the 4th floor Hibla Gallery facing Northwest, and blue quadrant outlining the Heritage Collection Councils (HCC) 's targets for hot, humid climates: 22-28oC and 55-70%RH, Right: 4th floor Hibla Gallery, NMA building comparing the wet (purple) and dry (yellow) seasons and the blue quadrant outlining HCC's target.

Figure 7 shows two psychrometric plots for the 4th floor NMA building over one year from 30 March 2020 to 3 March 2021. On the left is the Rice Gallery which faces southwest and the Hibla Gallery towards the northwest. Both plots show sustained high levels of relative humidity and temperature, three quarters outside the HCC targets. This is greater for the Rice Gallery that faces more towards the south and experiences the higher building climatic loads from the sun and elevated daytime temperatures. Of note is the wet and dry season of the Hibla Gallery (see Figure 7 on the right). Risk points are relevant to half of the dry season and all of the wet season when values are above the 70% biodeterioration threshold. As will be examined later, the intermittent operations of the AC units, caused condensation on the surface of the collections which are mostly organic. Similarly, the 3rd floor NMA plots follow the same trend with variations between the galleries facing northwest, the Bangsamoro and Lumad Gallery, and east facing, the Biyay Gallery. Assuming all the HVAC systems are performing well, it seems each gallery space holds a climate specific to its location in the building and floor level. Understanding what each gallery can achieve is a key step towards the zoning of climates for collection types and risk levels.

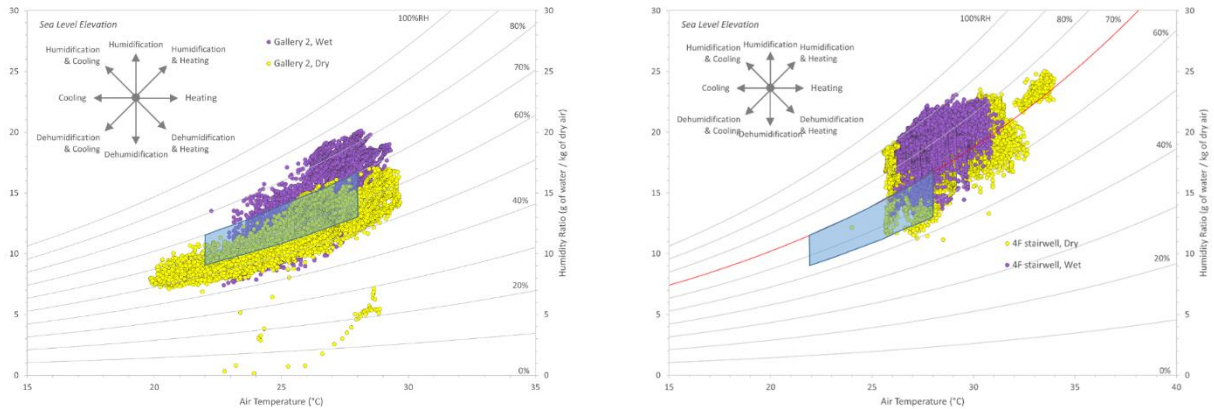
Figure 8. Psychrometric plot of the National Museum of Fine Arts, coloured blue quadrants outlining the Heritage Collection Councils (HCC) ’s targets for hot, humid climates: 22-28°C and 55-70%RH. The red line is the 70%RH threshold for biodeterioration. Left: 2nd floor Gallery 2 facing west from data obtained from 6 December 2017 to 23 February 2019, air conditioning on in the day and off at night with the wet season (purple) and dry season (yellow); compared to Right: the 4th floor stairwell, internal location without air conditioning from 10 April 2017 to 15 July 2018,

While the psychrometric plots from the NMFA's Gallery 2 as shown in Figure 8 on the left and Table 1, presents the intermittent use of HVAC and the

wet and dry season over a 1-year period from 6 December 2017 to 23 February 2019. Effectively, the dry season corresponds with the HCC targets and the

wet season does not, highlighting the ‘at risk’ period above 70%RH. This is when extra attention and the use of dehumidifiers is necessary. The monitoring of dehumidifiers, emptying of accumulated water and record keeping, was a task assigned to the security staff, which during the wet season was about one bucket plus every morning (Balarbar, 2023). Figure 8’s two psychrometric plots is also useful to compare intermittent use of HVAC in Gallery 2 on the left, with an internal location with no mechanical controls on the right. Located in a stairwell on the 4th

floor, the plot on the right with no climate controls, corresponds very little with the HCC targets. The option of non-mechanical climate controls within the NMFA building is, therefore, not a real possibility. As a retrofitted historic building in the tropics, the NFMA has ‘poor air control performance’ with air exchanges through windows and doors, and this can amplify external climates rather than reduce extremes. The small daily variations in the tropics, means that overnight cooling is difficult.

and b, and the climates the collections are intermittently exposed to. The effects of large climate changes are also evidenced in Gallery 2 of the NMFA building. Panel paintings as composite collections, appear to be undergoing dimensional changes and cracks, and delaminated paint forms soon after treatment. Annually datalogging over the wet and dry season shows 43-73%RH and 20 -30°C, beyond the tolerable fluctuations of 20%RH and the increase risk of fracture (see left plot in Figure 8) (ASHRAE 2019).

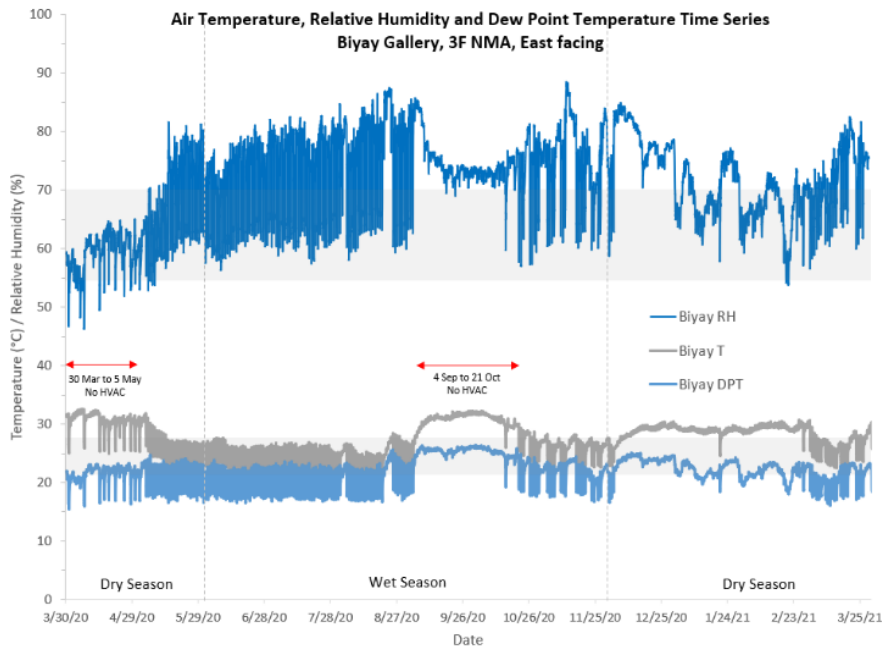
Figure 9. 3rd floor of the NMA building shows how the temperature and %RH readings stabilized when the mechanical controls were not used from 30 March to 5 May 2020 and 4 September to 21 October 2020 as indicated by the red arrows. Readings from the Biyay Gallery on the 3rd floor of the National Museum of Anthropology. The grey band indicates the 70%RH threshold target for biodeterioration, and the lower blue plot is the dew point. Graph was generated using the Onset Hoboware Software for Data Loggers and Devices, Version 3.7.26, 2023.

Like many collecting institutions worldwide, the pandemic has offered the opportunity to assess the performance of buildings without mechanical systems for collection care. Such was the case for NMP and Figure 9 from the 3rd floor of the NMA building shows the Biyay Gallery and how the temperature and %RH readings stabilized when the mechanical controls were not used from 30 March to 5 May 2020 and 4 September to 21 October 2021 (the same trend was found for the Bangsamoro, and Lumad Galleries on the 3rd floor). The maximum %RH levels dropped from between 80-90%RH to 70%RH to minimize

mould risk, as did the dew point temperature and the %RH range to +/- 5%RH. Temperatures also stabilized and flatlined to above 30°C. This is outside the environmental standards mentioned earlier and could result in thermal ageing up to 3-4 times faster compared to 20°C, if for example, a work on paper, picture varnish or weighted silk (Tetrault & Dupont, 2019; Michalski, 2002). When mechanical climate controls are not in use, it is clear there are the competing impacts such as the reduction biological risks vs increased thermal ageing, to the benefits of energy savings vs access if galleries are cooled with HVAC.

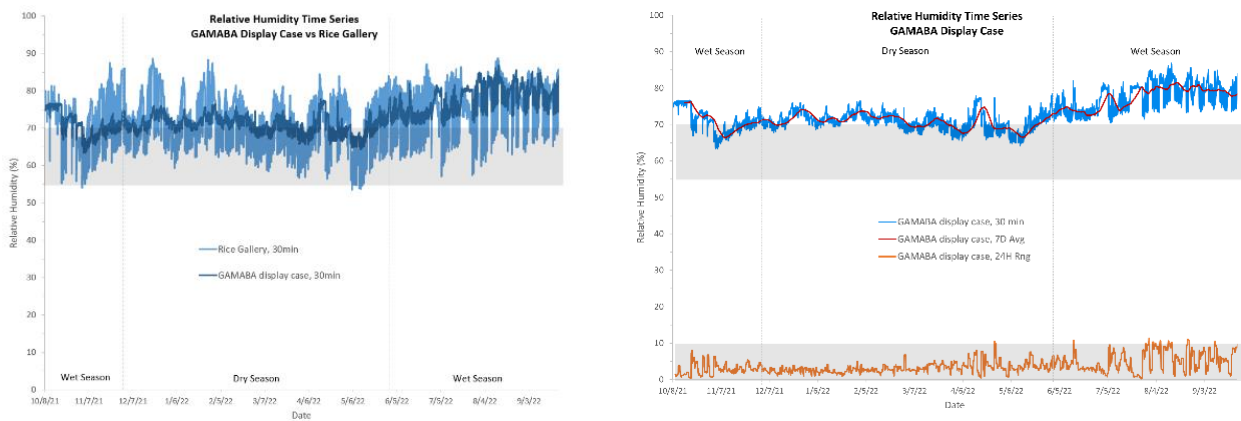
Figure 10. NMA Building showing the effects of a microclimate display buffered with silica tray drawers compared to an internal gallery space, both southwest facing galleries, time series plots, 8 October 2021 to 23 September 2022 over a wet to dry to wet season. Left: GAMABA display case on the 3rd floor, and the 4th floor Rice Gallery, time series 30 min moving range, Right: GAMABA display case with 3 time series plots at a 30 minute, 7 day average and 24 hour moving range.

To assess when the risk of mould may occur, Figure 10 shows a time series plot with data from the NMA building. It compares two locations, one within the GAMABA display case as an example of a microclimate to buffer the extremes, and one within the Rice Gallery, on a different floor but also a southwest facing gallery. The GAMABA display case buffered with silica gel, reduces the extremes in temperature and %RH compared to the Rice Gallery, but levels are

above the 70%RH risk threshold for mould. The potential for mould would therefore be contained within the case and the limited air movement, contributes more risk. The demands of the wet season are also shown. In the initial months, the GAMABA display performs better than in the latter wet season, when humidity rises above the 70%RH threshold and the 24 hr range increases above 10 %RH. Here, either the silica gel is saturated and not performing, or the display case is not retaining its micro-climate.
