Urban billabong restoration benefits from Traditional Owner involvement and regular flooding

Greet J *et al.* (2023)
Marine and Freshwater Research
doi:[10.1071/MF22195](https://doi.org/10.1071/MF22195)

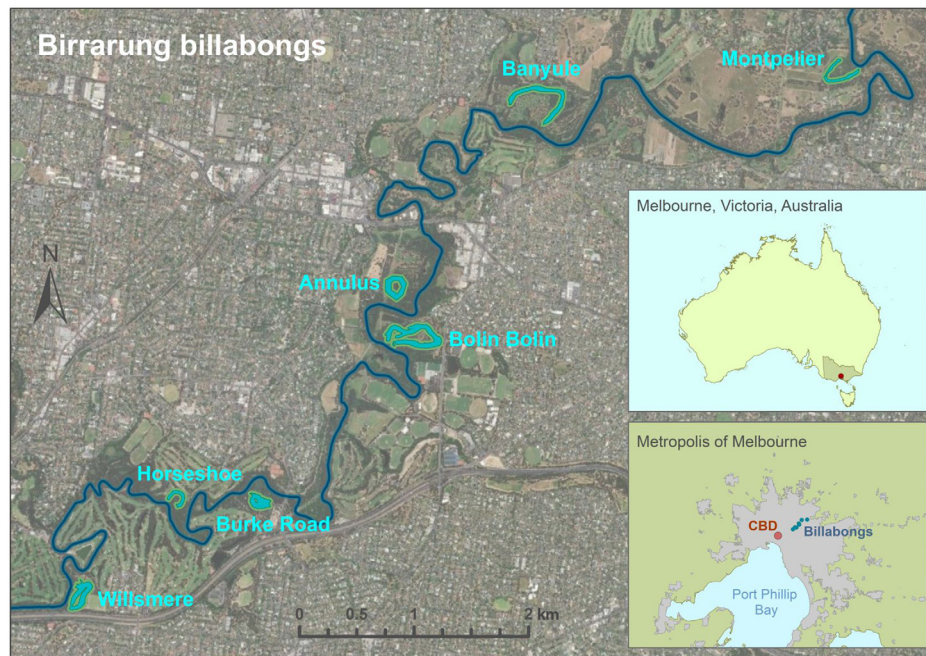
Fig. 1. Map of seven billabongs along the lower Birrarung (Yarra River) that were the focus of this study.

Seven billabongs along the lower Birrarung form the basis of this study: Annulus, Banyule, Bolin Bolin, Burke Road, Horseshoe, Montpellier and Willsmere (Table 1, Fig. 1). These sites are part of a cultural landscape which has been shaped by Wurundjeri Woi Wurrung occupation and land management for generations (Freedman 2020). These billabongs were previously identified as sites of ecological significance through a prioritisation process undertaken by Melbourne Water. The billabongs were also selected because they represent a gradient from more to less connected to the Birrarung. The estimated volumes and commence-to-fill flow levels based on LIDAR and gauged flows in the Birrarung at Banksia Street, Heidelberg (Melbourne Water stream-flow gauge 229135A) are shown in Table 1. Many of these billabongs have received environmental watering (by pumping from the river) in recent years, including Banyule in 2019 and Annulus in 2020 and 2021 (Table 1).

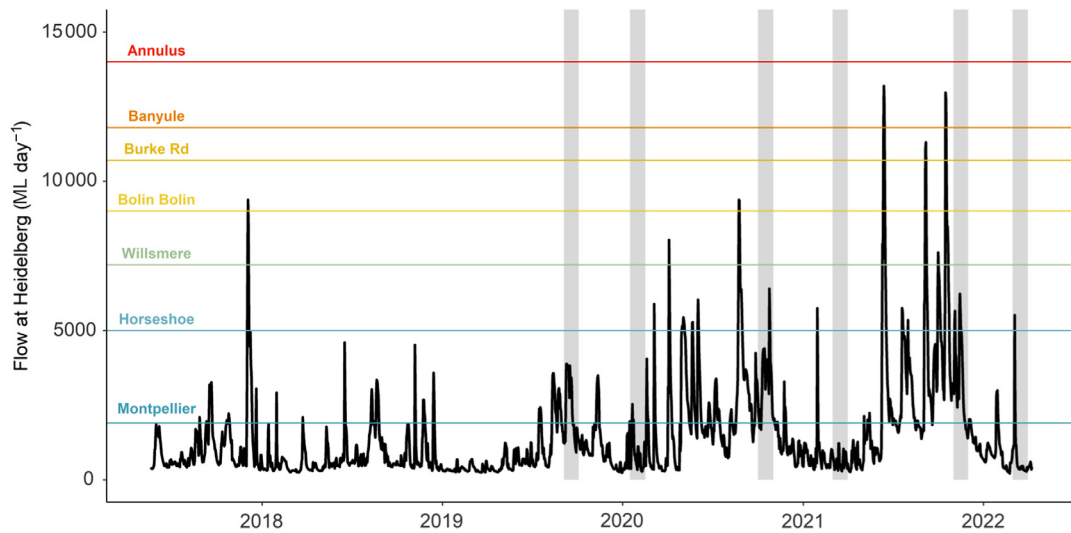
Fig. 2. River levels in the Birrarung (Yarra River) at Banksia Street, Heidelberg, between 01/01/2016 and 1/04/2022 (black line) with the commence-to-fill flow levels indicated for the seven billabongs (CTF levels determined by Jacobs by using LIDAR; Jacobs, unpubl. data, 2019). When river flows in the Birrarung reach the respective CTF levels, the corresponding billabong is flooded by overbank flows; e.g. there were two significant flood events in 2021 when all billabongs except Annulus flooded by overbank flows. Timing of the spring and autumn vegetation surveys are indicated by grey vertical bars.

connecting (by overbank flows) to the Birrarung at different flow levels (Table 1). In general, 2019 was a relatively dry year, 2020 an average to wet year, and 2021 a particularly wet year (Fig. 2). In 2019, only two billabongs flooded, namely, Montpellier (naturally by overbank flows) and Banyule (environmental watering). In 2020, two billabongs, namely, Burke Road and Banyule, remained dry, with the others flooding by overbank flows, except Annulus, which received environmental watering. In contrast, in 2021 all billabongs flooded naturally by overbank flows, many on several occasions (Fig. 2), except Annulus, which received environmental watering in September, with flooding lasting for 3 months. All of the billabongs were deeply flooded (to >1 m deep) at the time of the spring surveys in November 2021, and all billabongs except Annulus remained partially flooded in March 2022 (i.e. were flooded for up to 8 months).

Given the lack of detailed hydrological data for most sites, flooding variables were inferred from flow data for the Yarra River and commence-to-fill levels of the respective billabongs (Fig. 2), and were checked against our survey notes on water depth and detailed anecdotal accounts provided by Sarah Gaskill (Melbourne Water). All analyses were conducted in R (ver. 4.1.0 (2021-05-18), R Foundation for Statistical Computing, Vienna, Austria, see <https://www.r-project.org/>).

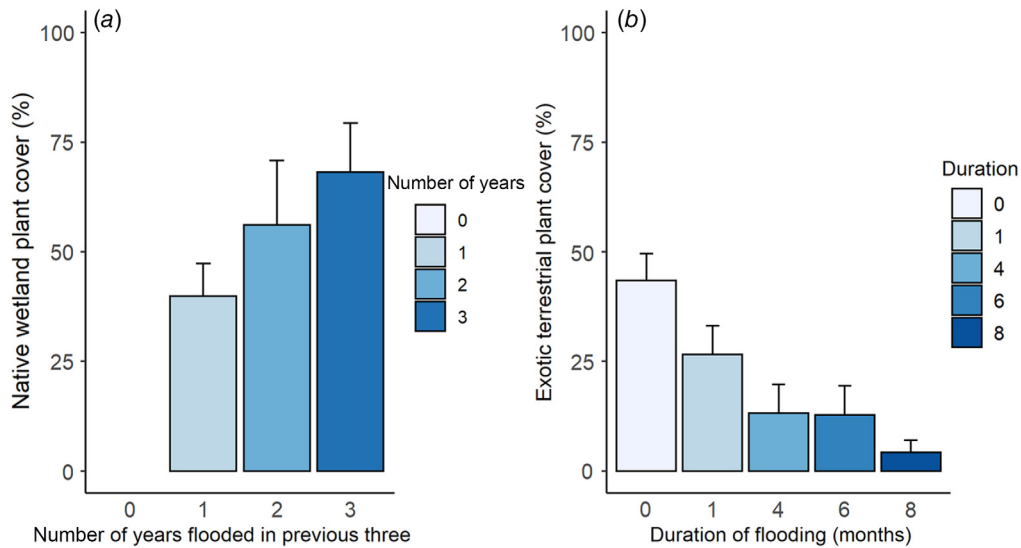
Fig. 3. Relationships between native wetland plant cover and exotic terrestrial plant cover and flooding: (a) native wetland plant cover increased with the number of times a billabong was flooded in previous 3 years; (b) exotic terrestrial plant cover reduced with longer duration of flooding (months prior to survey).

Considering only autumn surveys, the number of years a billabong was flooded in the past 3 years was important ($P = 0.05$) in determining native wetland plant cover, with sites flooded in two or three of the past 3 years having >50% native wetland plant cover (Fig. 3a).

For exotic terrestrial plant cover, the duration of flooding in the previous year was most important ($P < 0.001$), with exotic terrestrial plant cover decreasing from ~50% in the absence of flooding to <5% after 8 months of flooding prior to the survey (Fig. 3b).

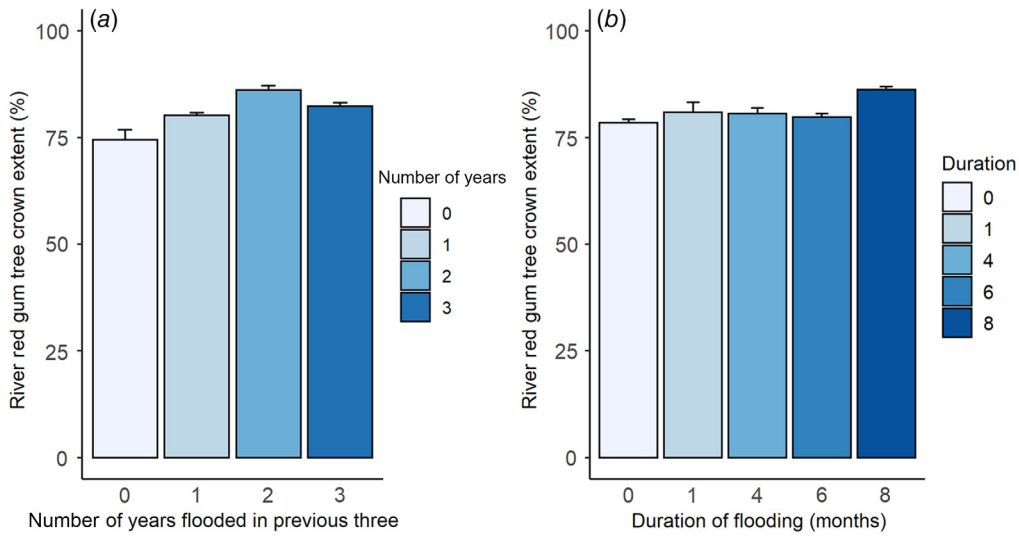
Fig. 4. Relationships between mean tree condition (crown extent, %) of river red gums at six billabongs and flooding. Tree condition increased with (a) the number of times a billabong was flooded in previous 3 years, and (b) duration of flooding (months prior to survey).

Considering all three surveys, trees were in better condition when billabongs were flooded more regularly ($P = 0.002$) and for longer ($P < 0.001$; Fig. 4a, b). Trees were generally in best condition (86%) when billabongs had been flooded for two of the previous 3 years, and worst (74%) at billabongs that had not been flooded in the previous 3 years. The mean condition of river red gum trees was almost 10% better when flooded for 8 months in the preceding year than not at all (86% cf. 78%).

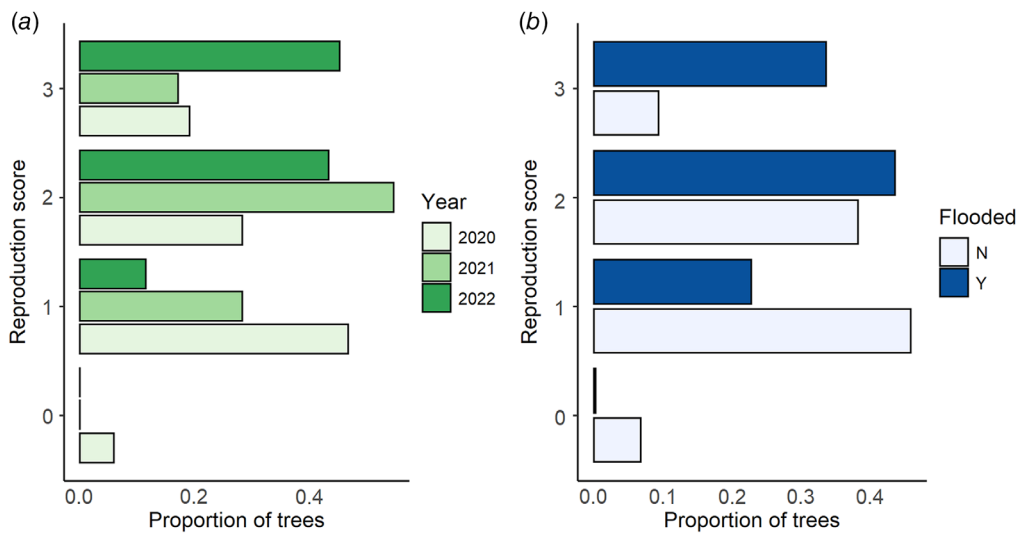
Fig. 5. Extent of sexual reproduction (abundance of buds, flowers and cones) of river red gums surveyed at six billabongs in years 2020–22 and (a) year of survey, (b) whether or not the billabong had been flooded in the previous year.

Reproduction scores (abundance of buds, flowers and cones) recorded for surveyed trees were considerably higher in 2022 than in previous years. In 2022, almost half (45%) of all trees surveyed had abundant buds, flowers or cones compared with less than 20% of trees in 2020 and 2021 (Fig. 5a, 6). Across all years, reproduction scores were higher at billabongs that had been flooded in the previous

year than at those that had not been flooded (Fig. 5b). One-third (34%) of all river red gums at billabongs that recently flooded had abundant buds, flowers and cones, compared with 9% for those at billabongs that had not been flooded.
